Notice! This schematic
matches board version 1.4
VS1010Dev1_43
10.12.2018 13.53
Sheet: 1/3

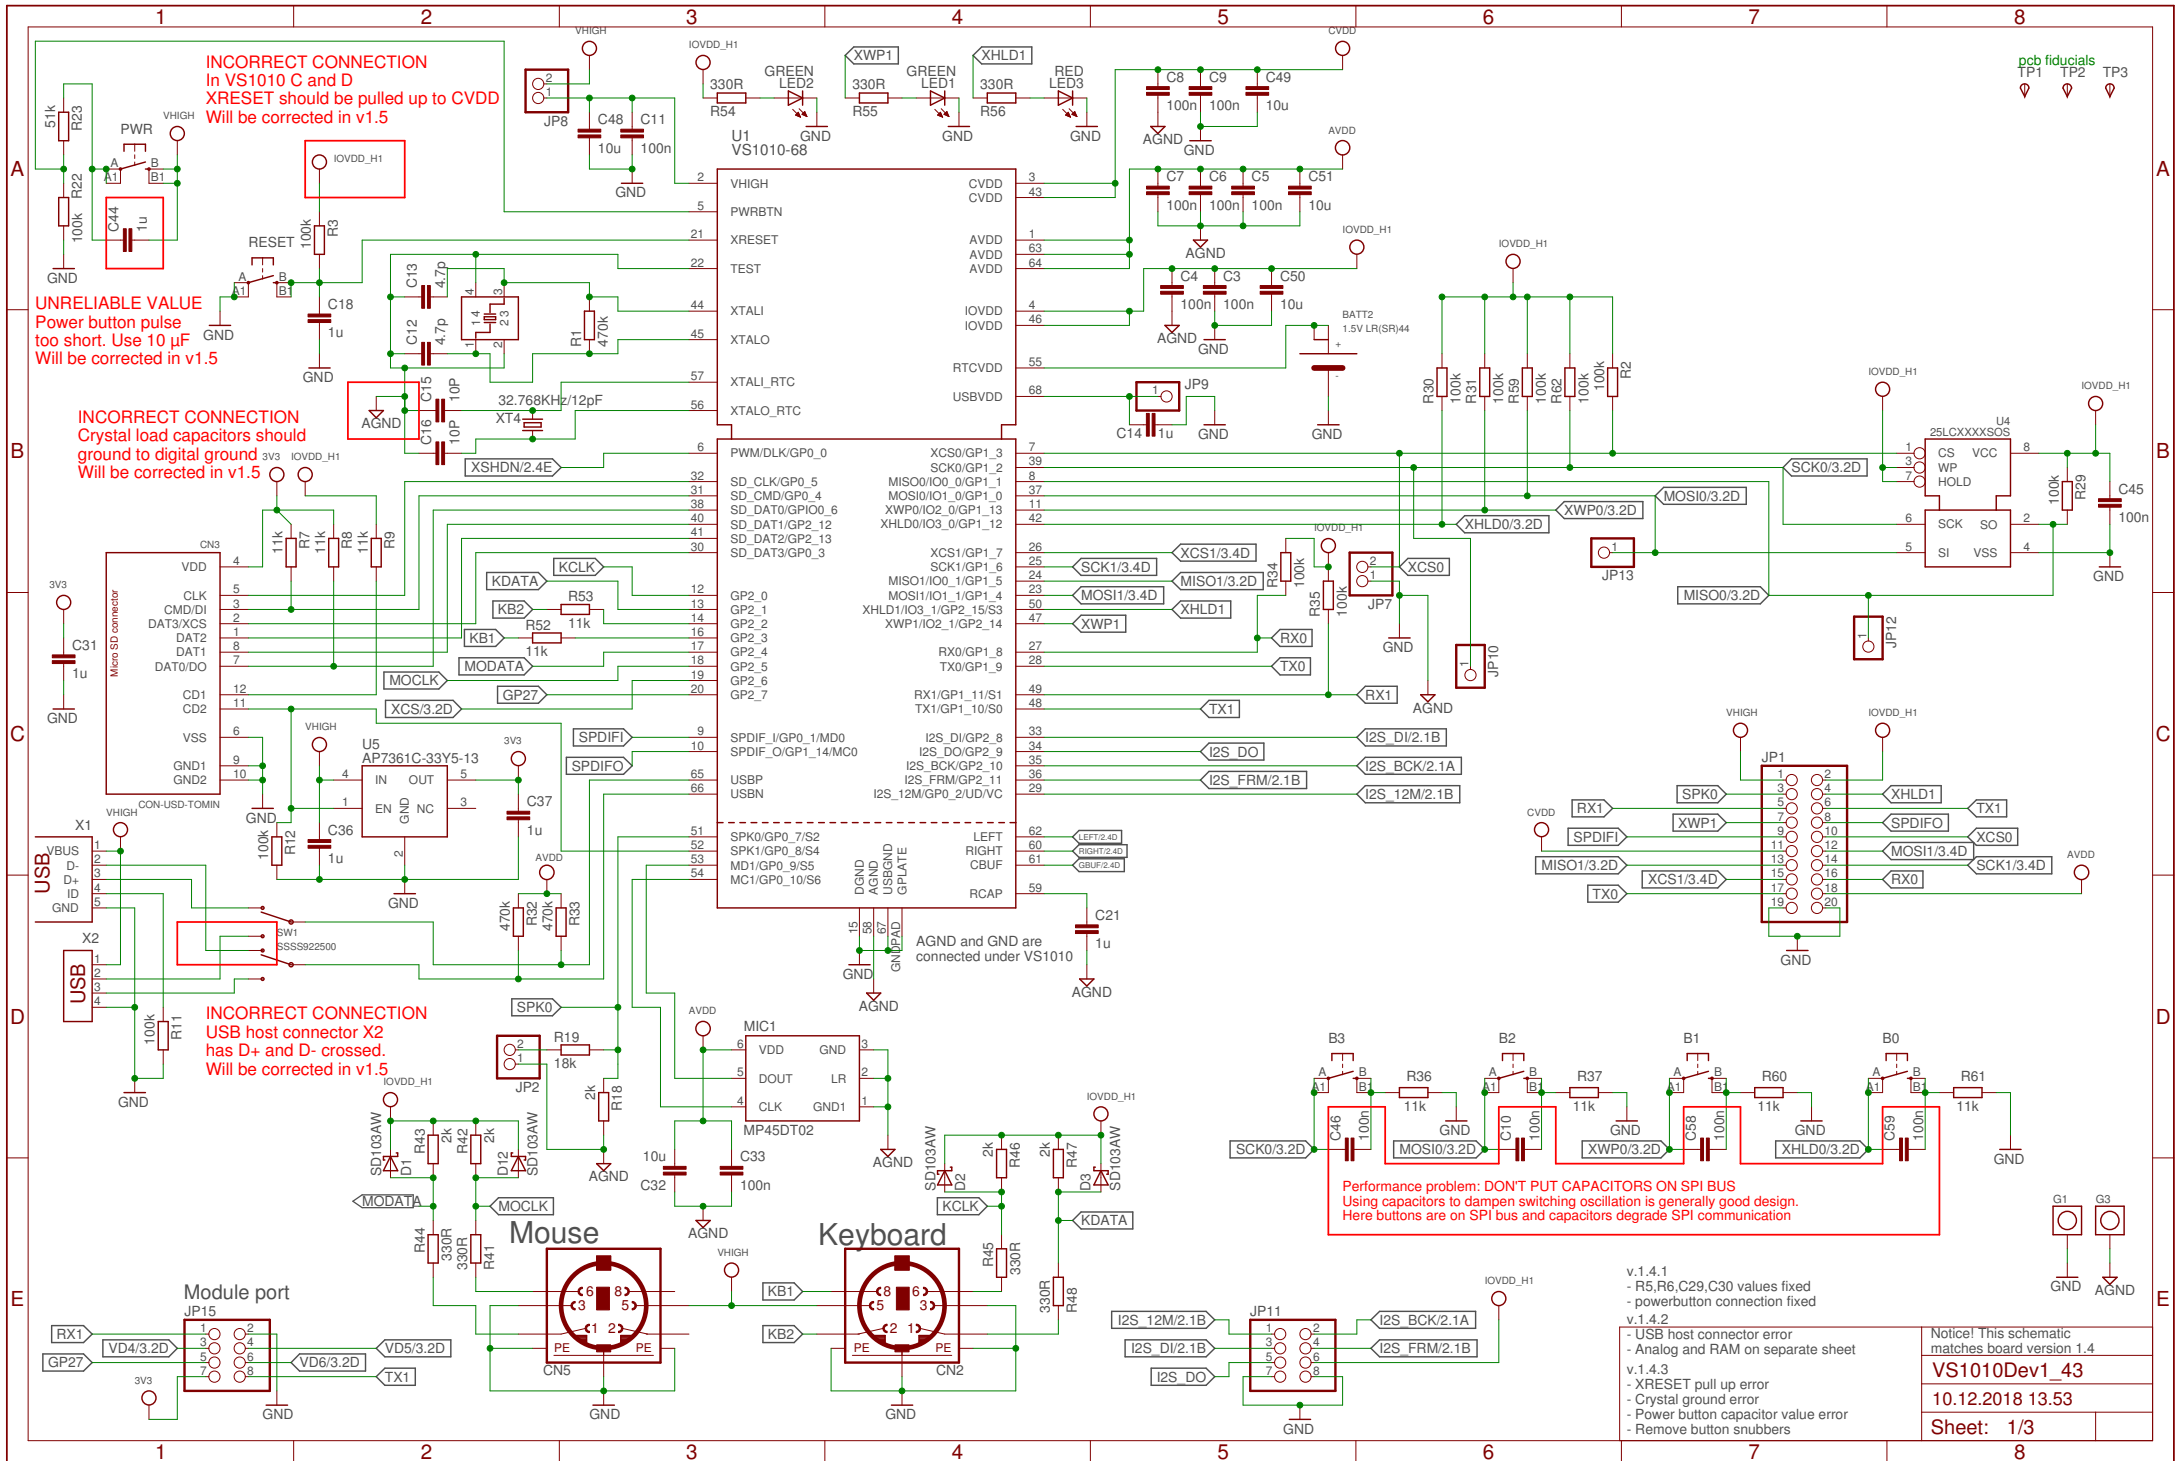
INCORRECT CONNECTION
In VS1010 C and D
XRESET should be pulled up to CVDD
Will be corrected in v1.5

UNRELIABLE VALUE
Power button pulse
too short. Use 10 μF
Will be corrected in v1.5

INCORRECT CONNECTION
Crystal load capacitors should
ground to digital ground
Will be corrected in v1.5

INCORRECT CONNECTION
USB host connector X2
has D+ and D- crossed.
Will be corrected in v1.5

Performance problem: DON'T PUT CAPACITORS ON SPI BUS
Using capacitors to dampen switching oscillation is generally good design.
Here buttons are on SPI bus and capacitors degrade SPI communication

v.1.4.1	- R5, R6, C29, C30 values fixed
	- powerbutton connection fixed
v.1.4.2	- USB host connector error
	- Analog and RAM on separate sheet
v.1.4.3	- XRESET pull up error
	- Crystal ground error
	- Power button capacitor value error
	- Remove button snubbers
