Notice! This schematic
matches board version 1.4
VS1010Dev1_43
10.12.2018 13.53
Sheet: 1/3

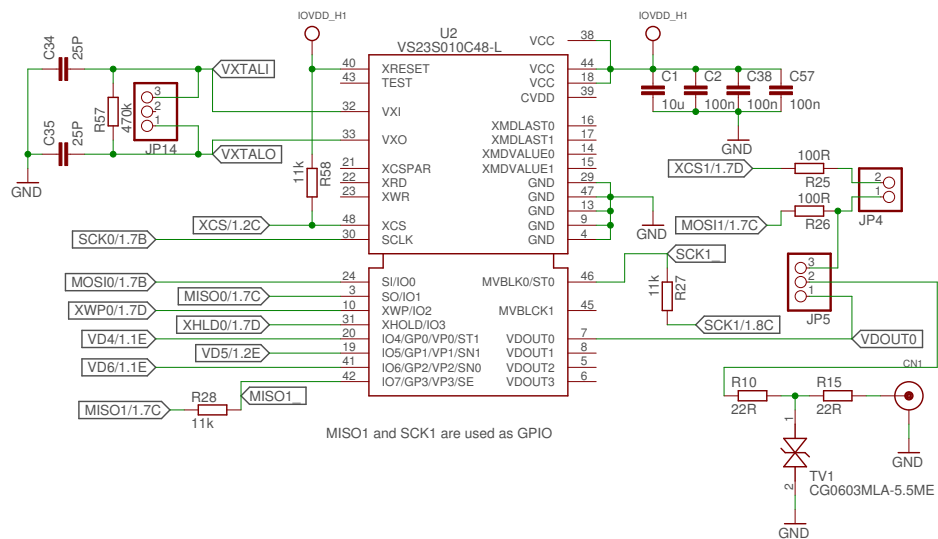
VS23S010 is populated on VS1010 developer board 1.4. The chip is on the top side.

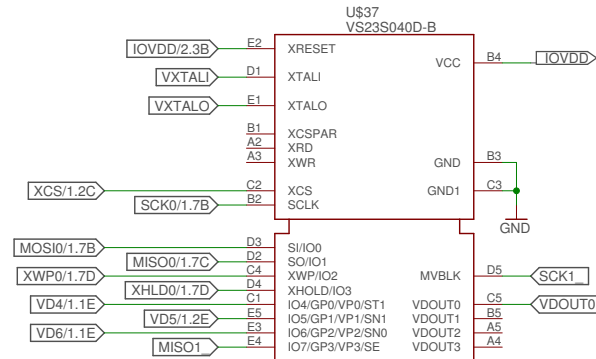
VS23S040 is not populated on VS1010 developer board 1.4. Footprint is on the bottom side.

Only one of VS23S010 or VS23S040 may be populated.
